# Container Terminal No. 9, Hong Kong

In May 2002 the construction of the Container Terminal No.9 commenced in Hong Kong. Controlled Permeability Formwork (CPF) was specified for the casting of quays.

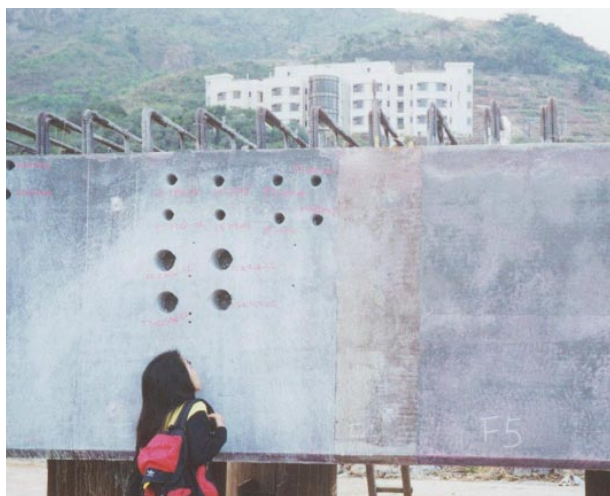
Figure 2. The trial beam, with the competing product (left), without formliner (middle) and Formtex<sup>®</sup> (right).

The contractor, Hyundai, carried out a trial in Nov 2001 to determine the effect of different CPF liners.

Formtex<sup>®</sup> was glued to the same metal formwork as the competing products, and the liners were tested in the same casting, so they had exactly the same conditions to perform.

The concrete cast with the competing CPF-liners appeared smooth but with some cracks. The concrete cast without using formliner appeared rough and with many blowholes. Concrete with Formtex<sup>®</sup> appeared smooth and dense. On the bases of these results and a consecutive testing at an independent test laboratory, Formtex<sup>®</sup> was selected for the Container Terminal No. 9 Project.

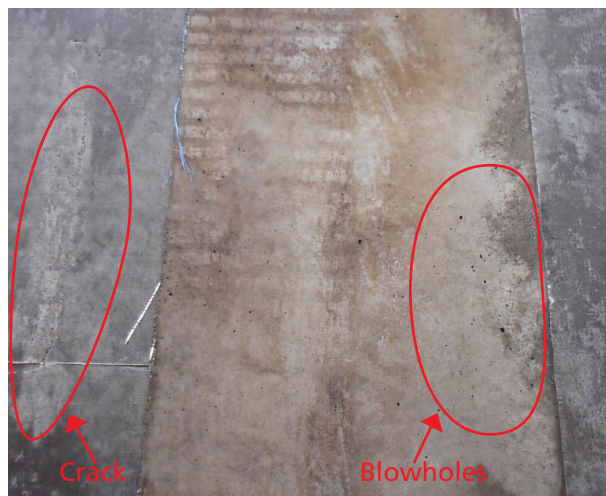
Figure 3. Achieved concrete for competing product (Left), without formliner (middle) and Formtex<sup>®</sup> (right)

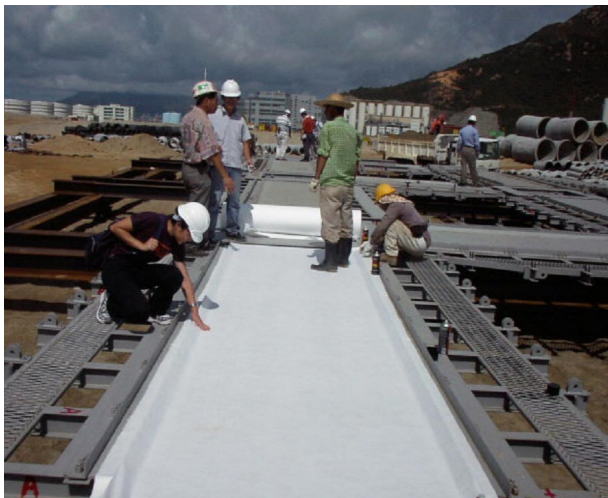
Figure 4. Formtex is installed on the base of the formwork for the beam.

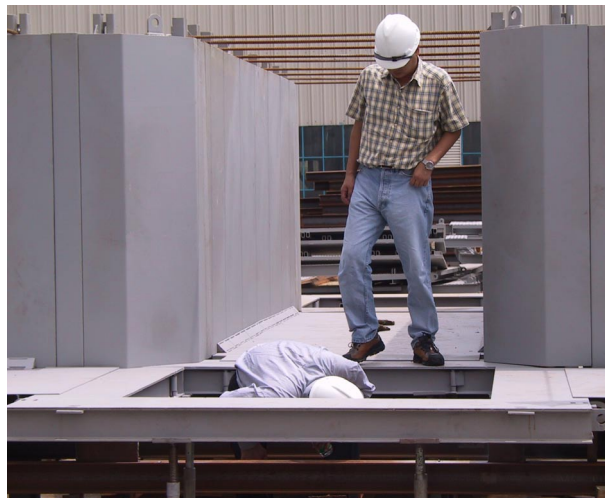
Figure 5. The formwork for the huge beams is inspected.

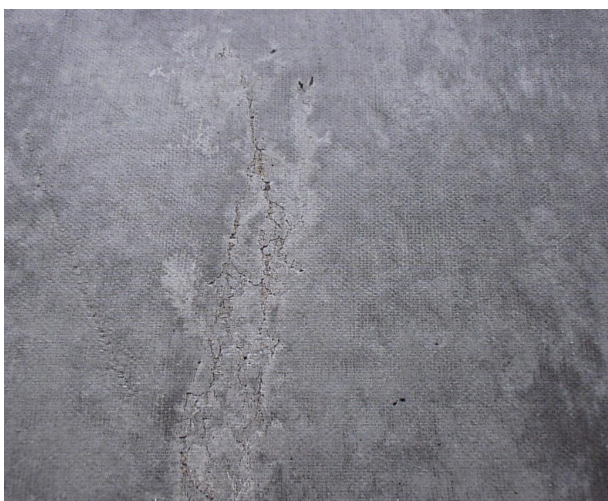
Figure 6. A large crack in the surface of the test of the competing product.

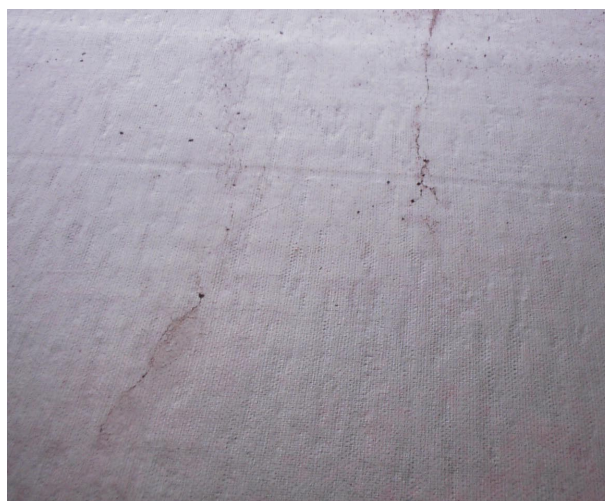
Figure 7. Several cracks in the surface of the test of the competing product.

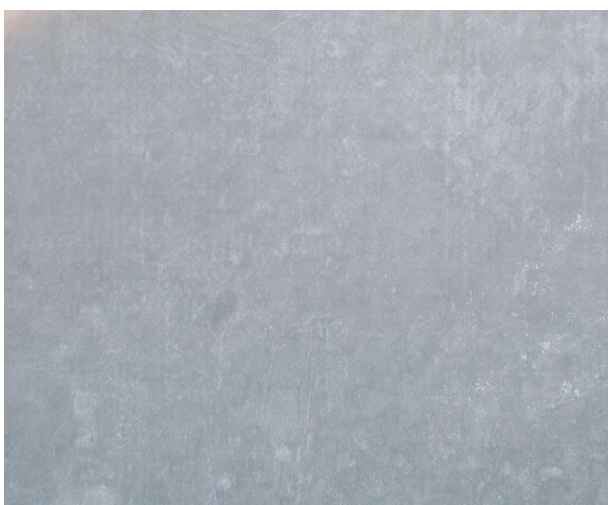
Figure 8. Surface achieved with Formtex<sup>®</sup>

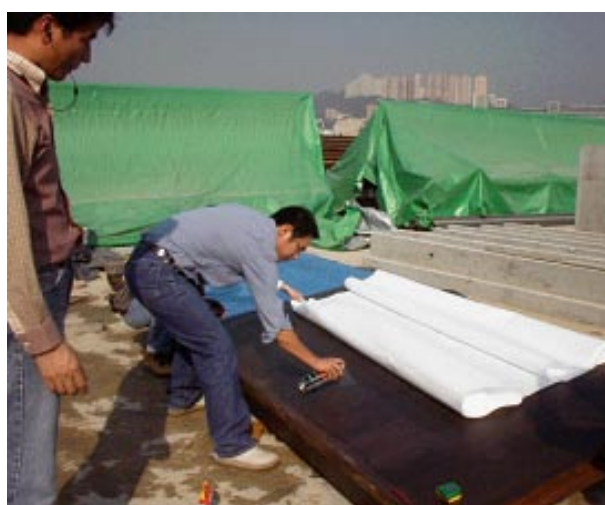
Figure 9. Test formwork is prepared with the competing product on the left and Formtex<sup>®</sup> on the right.
